Dowager's Return

A log of an eight-year metamorphosis of a New York 30 from her original gaff-rigged sloop design to a modern jib-headed yawl. Her owner says she "is as sound as a pre-Roosevelt dollar"; her mint condition belies her advanced age—fifty-nine years old!

Popular Boating
May 1964

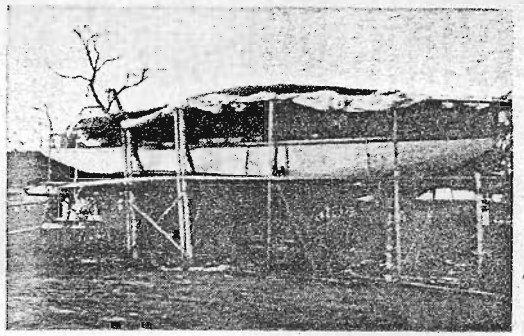
Great experiment of 1963 was the covering of *Cockatoo's* hull with Dynel. Bulwark was also added at the same time.

Despite the attempts of knowledgeable friends to dissuade us, we had for years considered fiberglassing the hull. But after reading about Lindsay Lord's experiments with Dynel ("A New Miracle Material?", POPULAR BOATING, Feb. 1962) we decided to try it. But first we had to modernize the deck and gunwales, which was done by laying down two layers of plywood—the first $\frac{1}{4}$ " mahogany, the second $\frac{1}{2}$ " fir—bedding them in polyurethane. While the old deck was off we found time to relocate the chainplates inside the hull to facilitate the up-coming sheathing operation. The new deck was finished off with one coat of Dynel laid in polyester. To get in style with modern ocean racers, we added a modest bulwark which was capped with mahogany. Then, back to those garboard seams—again! We routed them out to virgin wood, fabricated and fitted pine wedges to go in each seam, took them out and finally drove them back in place in a bed of polyurethane. After they had cured for several weeks we trimmed off the excess. Any remaining gaps were filled with a glass-resin-Thiokol putty.

The application was a three-man job. One mixed, two others applied the resin with rollers. It was found most convenient to wet the surface with resin before applying the cloth—essential, as a matter of fact, in the way of the lead. Bronze staples were used to tack the cloth in place temporarily, especially in the area at the turn of the bilge. The first layer was applied vertically working down from the top of the bulwark. The second layer was applied in longitudinal strakes. While butts were intentionally minimized, any overlaps were ground smooth—a tedious job, but necessary. We then proceeded to smooth up the whole surface, which was even more tedious.

The Great Experiment of 1963—the Dynel sheathing—was also a success. When hauled on December 7th, *Cockatoo II* was as dry as a bone and those blasted garboard seams were no longer a problem. There was, however, one small 2'x2' patch of about nine bubbles, where the resin evidently remained uncured. A simple job to fix. There was no sign of working planks or seams, although there was a minor protrusion in some of about one or two thousandths. These will be sanded off without compromising the Dynel and when she is repainted no seams will be visible in her topsides.

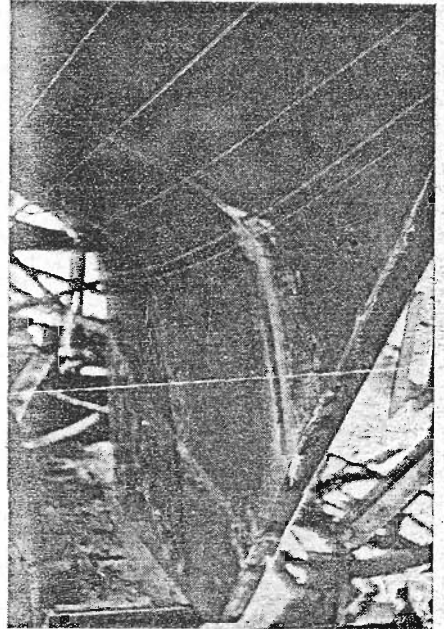
Seams permanently closed with wooden wedges, Dynel was applied in two layers.

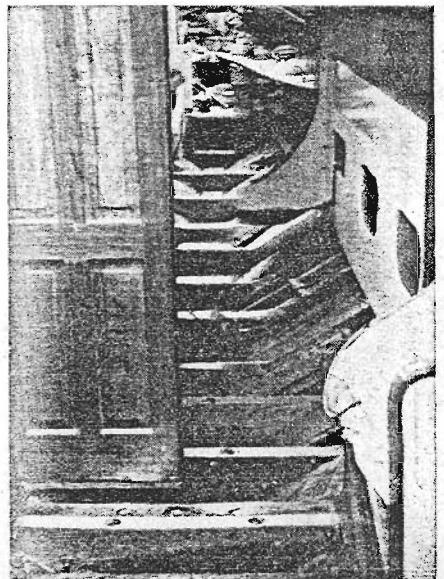
Rotting floors caused *Cockatoo II's* keel to rock slightly. Solution was installation of eight bronze sister floors, Monel fastened.
